**Flood Control Project Maintenance
Levee Inspections**
LMA District Cover Sheet
Spring 2018 Levee Inspection Results

Reclamation District No. 0010 Honcut

Spring 2018 Levee Inspection Results

Waterway			Bank	Unit Miles
Unit No. 01 Simmerly Slough			Right	7.65
	Spring (March - May)	Summer (June - August)	(September - November) Fall	Winter (December - February)
Unit Maintenance Rating (Fall Only)				
Date of Inspection	4/10/2018 - 4/10/2018			
DWR Inspector	Sterling York			
Accompanied By	Finlay Williams

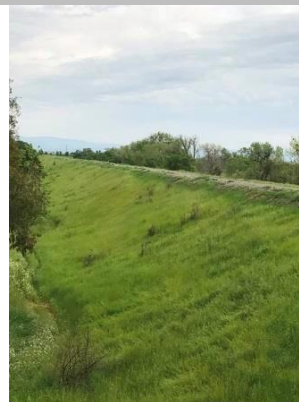
Photo 1 of 1 : SP_2018_RD0010_163_1_20180411_00093.jpg

LM Start	0.00	Rating **	A	Issue No.	1
LM End	1.36	Issue Type +	Ma	Location *	LS
Category	Earthen Levee			GPS Latitude/Longitude	
				Start	End
Item	Vegetation			39.163724 °	39.168775 °
				-121.609935 °	-121.590443 °
DWR ID	DWR_RD0010_01_s_2018_1				
Comment Code					
V1 : Control annual grass and weeds on the levee slopes and easements.					
Inspector Comment					
Annual vegetation is maintained, Spring 2018.

View looking upstream landside of maintained annual vegetation, Spring 2018.

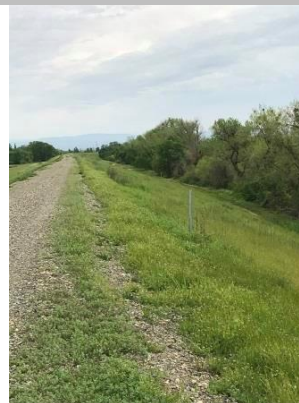
Photo 1 of 1 : SP_2018_RD0010_163_29_20180411_00094.jpg

LM Start	0.00	Rating **	A	Issue No.	29
LM End	1.36	Issue Type +	Ma	Location *	WS
Category	Earthen Levee			GPS Latitude/Longitude	
				Start	End
Item	Vegetation			39.163725 °	39.168775 °
				-121.609935 °	-121.590442 °
DWR ID	DWR_RD0010_01_s_2018_29				
Comment Code					
V1 : Control annual grass and weeds on the levee slopes and easements.					
Inspector Comment					
Annual vegetation is maintained, Spring 2018.

View looking upstream waterside of maintained annual vegetation, Spring 2018.

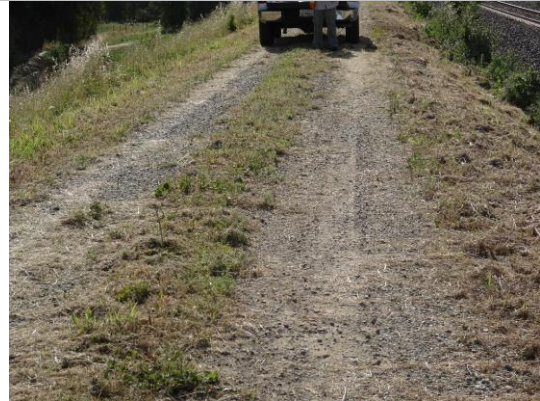
Photo 2 of 3 : UCIP_SP_2018_24806_44541.jpg

FS_ID:24806
DS_ID:21257
EP_NO: 13015
Repair Type: Non-Urgent
Crossing Status: Found
UCIP Comments: New gravel indicates work was recently completed. Will need to contact owner to obtain information pertaining to work completed. Need to contact owner to determine if crossing is still active and to determine last inspection date. Will need copy of letter showing crossings passed inspection. This crossing is referenced in the USACE Periodic Inspection as item USACE_CESPK_HON1_2013_p_0075. FIELD_STRUCT_DESC: 4-inch steel natural gas pipeline sleeved through an 8-inch pipe through the levee, 30 feet below the crown. Annular space grouted. Cutoff wall on each end within the levee. (Plans to reinforce an existing 4-inch gas main with a parallel 4-inch main through the levee authorized under Permit No. 13015, 1980 - Pacific Gas and Electric Company [PG&E]). [Additional Reference(s): DWR Levee Log, 2005].

View of levee crown looking downstream.

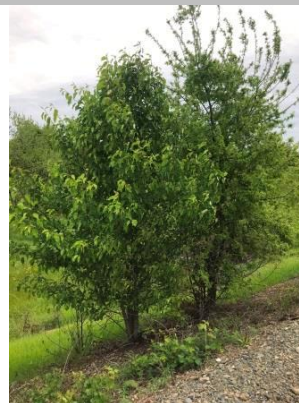
Photo 1 of 1 : SP_2018_RD0010_163_30_20180411_00095.jpg

LM Start	0.69	Rating **	M	Issue No.	30
LM End	0.69	Issue Type +	Ma	Location *	LS
Category	Earthen Levee			GPS Latitude/Longitude	
				Start	End
Item	Trim / Thin Trees			39.161341 °	39.161341 °
				-121.597529 °	-121.597529 °
DWR ID	DWR_RD0010_01_s_2018_30				
Comment Code					
T2 : Thin trees to allow visibility of the ground and room to flood fight.					
Inspector Comment					
Small trees need to be trimmed or removed if trunks are 4" at chest height, Spring 2018.

View looking upstream landside of small trees that need to be trimmed or removed if trunks are 4" at chest height, Spring 2018.

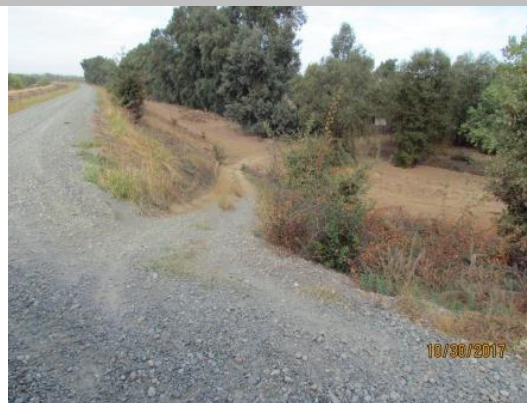
Photo 1 of 1 : SP_2018_RD0010_163_48_20180302_00019.jpg

LM Start	0.72	Rating **	M	Issue No.	48
LM End	0.72	Issue Type +	Ma	Location *	LS
Category	Earthen Levee			GPS Latitude/Longitude	
				Start	End
Item	Slope Stability			39.161198 °	39.161198 °
				-121.597102 °	-121.597102 °
DWR ID	DWR_RD0010_01_f_2013_48				
Comment Code					
S3 : Repair the levee slope damaged by vehicle traffic and prevent access where possible.					
Inspector Comment					
Ramp is caused by constant ATV foot traffic use on levee slope. Fall 2017.

View of the slope stability caused by foot traffic on the landward side of the levee looking downstream. Fall 2017.

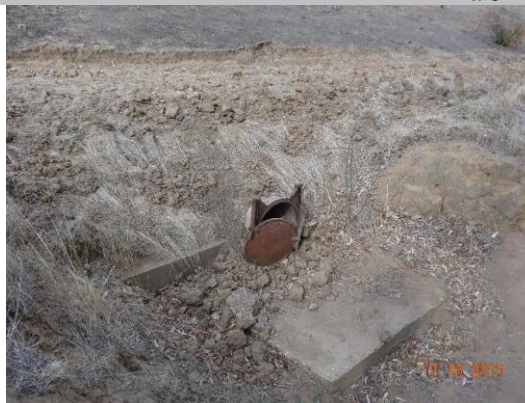
Photo 3 of 3 : UCIP_SP_2018_50058_51414.jpg

FS_ID:50058
DS_ID:21258
EP_NO: N/A
Repair Type: Non-Urgent
Crossing Status: Found
UCIP Comments: 7/01/2016 Gate has been repaired--WS gate is functional. LS gate still needs new stem for the gate to properly function--stem is bent. USACE's PI issue references permit number 13710 this is incorrect permit is associated with DS_ID 21259 (CLM 0.767). (DWR UCIP - omagana)4/29/2013 Damaged flap gate on waterward side and damaged stem on screw gate on landward side. Need to contact owner to determine if crossing is still active. If crossing is still in use owner will need to address damage on flap gate and screw gate. If crossing is no longer in use owner will need to contact the CVFPB to comply with Title 23. This crossing is referenced in the USACE Periodic Inspection as item USACE_CESPK_HON1_2013_p_0053 and 0057. (DWR UCIP - omagana)
FIELD_STRUCT_DESC: 24-inch corrugated metal gravity drainage pipe through the levee, 31 feet below the crown. Two corrugated metal cutoff walls around pipe. Concrete headwall at each end. Flap gate on the waterside (WS) end. Slide gate on the landside (LS) end. Pipe discharges into 6-foot concrete splash apron on the WS. [Additional Reference(s): DWR Levee Log, 2005. USACE Sacramento O&M Manual 151, May 1953, (Station 46+60)].

Damage flap gate located on WS.

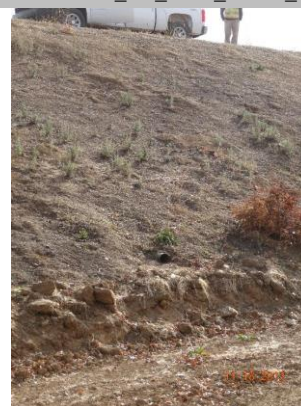
Photo 1 of 1 : UCIP_SP_2018_40545_51418.jpg

Comment Code					
Inspector Comment					
FS_ID:40545 DS_ID:21260 EP_NO: 4555 Repair Type: Non-Urgent Crossing Status: Indicator Found UCIP Comments: Pipe is approximately 4-6 inches in diameter located near the toe of levee. Crossing is approximately 50 feet downstream of 24-inch pipe. Need to contact owner to determine status of this crossing and to verify the purpose of crossing. If crossing is no longer in use owner will need to contact the CVFPB to comply with Title 23. FIELD_STRUCT_DESC: *ABANDONED* 6-inch steel drainage discharge pipe through the levee, 1 foot below the crown. Siphon breaker on the waterside (WS) shoulder. Pump at the landside (LS) toe. Revetment around the discharge end of the pipe. Pipe drains into a ditch at the WS toe. Pipe is not buried in berms. Gravel pad over pipe across levee crown for vehicular access. (Plans for installing a drainage pipe across the levee authorized under Permit No. 4555, 1964 - Ledbetter, Carbah, and Huddle). [Additional Reference(s): DWR Levee Log, 2005]. FS Date: 4/29/2013

Pipe through levee near waterward toe.

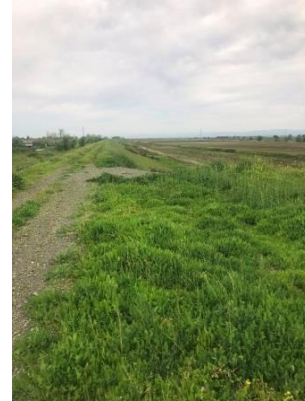
Photo 1 of 1 : SP_2018_RD0010_163_39_20180411_00099.jpg

LM Start	1.36	Rating **	U	Issue No.	39
LM End	7.64	Issue Type +	Ma	Location *	WS
Category	Earthen Levee			GPS Latitude/Longitude	
				Start	End
Item	Vegetation			39.168802 °	39.256072 °
				-121.590318 °	-121.574944 °
DWR ID	DWR_RD0010_01_s_2018_39				
Comment Code					
V1 : Control annual grass and weeds on the levee slopes and easements.					
Inspector Comment					
Annual vegetation is over grown, Spring 2018.

View looking upstream waterside of overgrown annual vegetation, Spring 2018.

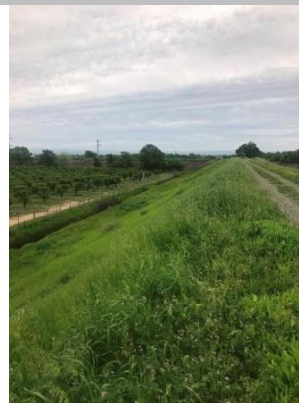
Photo 1 of 1 : SP_2018_RD0010_163_38_20180411_00100.jpg

LM Start	1.36	Rating **	U	Issue No.	38
LM End	7.64	Issue Type +	Ma	Location *	LS
Category	Earthen Levee			GPS Latitude/Longitude	
				Start	End
Item	Vegetation			39.168803 °	39.256072 °
				-121.590318 °	-121.574945 °
DWR ID	DWR_RD0010_01_s_2018_38				
Comment Code					
V1 : Control annual grass and weeds on the levee slopes and easements.					
Inspector Comment					
Annual vegetation is over grown, Spring 2018.

View looking upstream landside overgrown annual vegetation, Spring 2018.

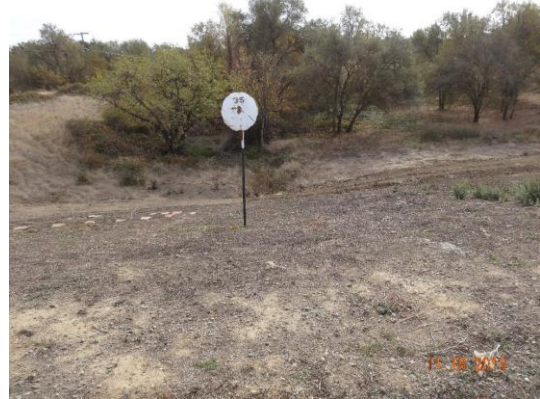
Photo 1 of 3 : UCIP_SP_2018_49986_44588.jpg

FS_ID:49986
DS_ID:21318
EP_NO: N/A
Repair Type: Urgent
Crossing Status: Found
UCIP Comments: 7/01/2016 Pipe wall in poor condition--deteriorated pipe wall indicated by holes at the inlet and outlet pipe collar. Recommend internal integrity inspection of the pipe through the levee to determine extent of damage. (DWR UCIP - omagana)4/29/2013
Holes present on pipe wall. Need to contact owner to notify of issue with pipe. Also need to contact DWR Inspector and CVFPB to determine how to address issue. This crossing is referenced in the USACE Periodic Inspection as item USACE_CESPK_HON1_2013_p_0140. Pipe should be 30-inch instead of 36-inch mentioned Periodic Inspection. (DWR UCIP - omagana)
FIELD_STRUCT_DESC: 30-inch corrugated metal gravity drainage pipe through the levee, approximately 30 feet below the crown. Two corrugated metal cutoff walls around the pipe on each side. Saddle and splash apron at the waterside (WS) discharge point. Concrete headwall and sluice gate on the landside (LS). [Additional Reference(s): DWR Levee Log, 2005. USACE Sacramento O&M Manual 151, May 1953, (Station 10+38)].

View of WS--marker present on WS shoulder.

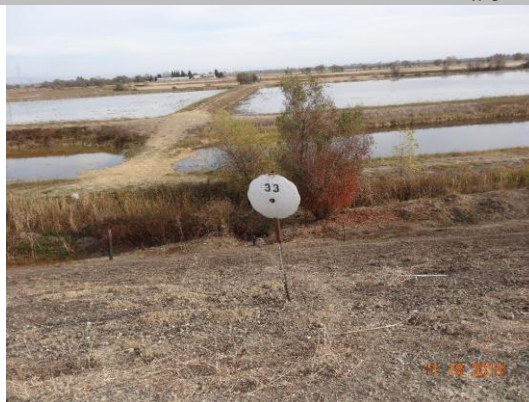
Photo 1 of 3 : UCIP_SP_2018_27745_51429.jpg

LM Start	2.14	Rating **	M	Issue No.	81
LM End	2.14	Issue Type +	En	Location *	
Category	Supplemental			GPS Latitude/Longitude	
				Start	End
Item	DWR UCIP Field Study			39.176936 °	39.176936 °
				-121.584848 °	-121.584848 °
DWR ID					
Comment Code					
Inspector Comment					
FS_ID:27745 DS_ID:21271 EP_NO: N/A Repair Type: Non-Urgent Crossing Status: Found UCIP Comments: Unable to determine if crossing is still present on landward side--need to confirm. Need to contact owner to determine status of crossing. This crossing is referenced in the USACE Periodic Inspection as item USACE_CESPK_HON1_2013_p_0185. FIELD_STRUCT_DESC: 24-inch gravity drainage pipe of an unknown material through the levee, 30 feet below the crown. Flap gate on the waterside (WS) end. Concrete headwall at each toe. [Additional Reference(s): DWR Levee Log, 2005]. FS Date: 4/29/2013

View of waterward side--marker indicating crossing visible on waterward shoulder.

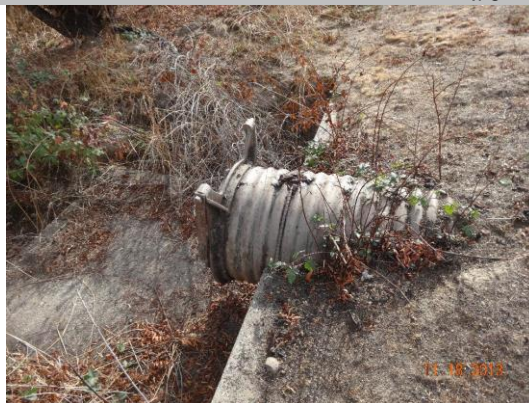
Photo 2 of 3 : UCIP_SP_2018_27745_51432.jpg

View of pipe, headwall, and flap gate located on waterward side.

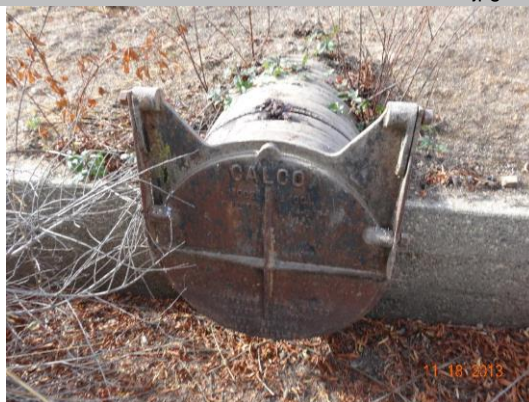
Photo 3 of 3 : UCIP_SP_2018_27745_51431.jpg

Flap gate appears to be in good condition.

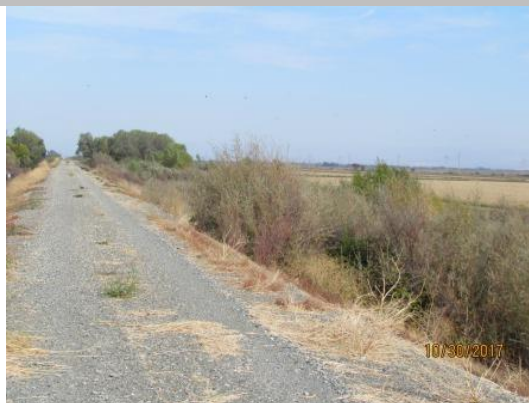
Photo 1 of 1 : SP_2018_RD0010_163_35_20180302_00009.jpg

LM Start	2.70	Rating **	M	Issue No.	35
LM End	2.70	Issue Type +	Ma	Location *	WS
Category	Earthen Levee			GPS Latitude/Longitude	
				Start	End
Item	Trim / Thin Trees			39.184974 °	39.184974 °
				-121.583836 °	-121.583836 °
DWR ID	DWR_RD0010_01_f_2017_35				
Comment Code					
T2 : Thin trees to allow visibility of the ground and room to flood fight.					
Inspector Comment					
Willows on levee slope need to be removed, Fall 2017.

View looking upstream waterside at Willow Trees that need to be removed, Fall 2017.

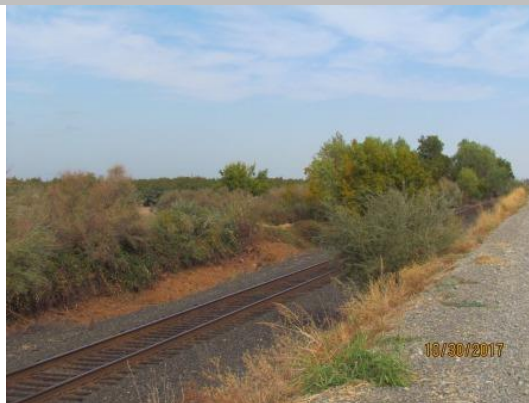
Photo 1 of 1 : SP_2018_RD0010_163_55_20180302_00025.jpg

LM Start	3.01	Rating **	M	Issue No.	55
LM End	3.01	Issue Type +	Ma	Location *	LS
Category	Earthen Levee			GPS Latitude/Longitude	
				Start	End
Item	Trim / Thin Trees			39.189497 °	39.189497 °
				-121.583308 °	-121.583308 °
DWR ID	DWR_RD0010_01_s_2016_55				
Comment Code					
T3 : Trim and thin trees to allow visibility of the ground and room to flood fight.					
Inspector Comment					
Small willow tree on landside slope should be removed. Fall 2017.

View of small willow trees on the landside slope looking upstream. Fall 2017.

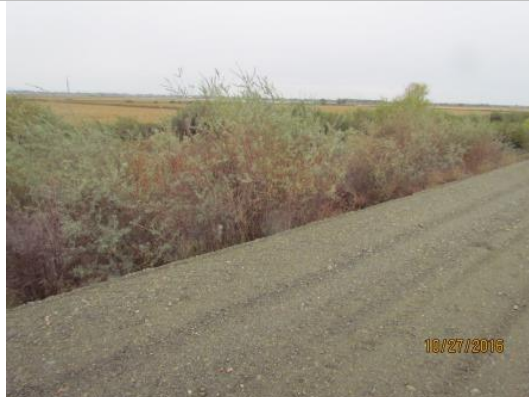
Photo 1 of 1 : SP_2018_RD0010_163_49_20180302_00020.jpg

LM Start	3.93	Rating **	M	Issue No.	49
LM End	3.93	Issue Type +	Ma	Location *	WS
Category	Earthen Levee			GPS Latitude/Longitude	
				Start	End
Item	Trim / Thin Trees			39.202570 °	39.202570 °
				-121.581681 °	-121.581681 °
DWR ID	DWR_RD0010_01_s_2016_49				
Comment Code					
T2 : Thin trees to allow visibility of the ground and room to flood fight.					
Inspector Comment					
Remove small willow trees from levee slope. Fall 2017.

View of small starter willow trees on the landside looking upstream. Fall 2016.

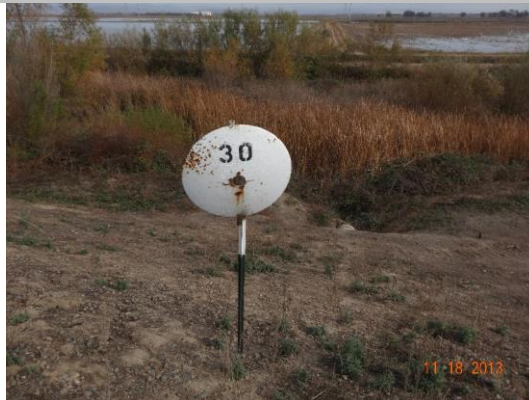
Photo 1 of 3 : UCIP_SP_2018_27747_51441.jpg

Comment Code						
Inspector Comment						
FS_ID:27747 DS_ID:21274 EP_NO: N/A Repair Type: Non-Urgent Crossing Status: Indicator Found UCIP Comments: sign marker on WS 30; Unable to confirm landward side. This crossing is referenced in the USACE Periodic Inspection as item USACE_CESPK_HON1_2013_p_0232. FIELD_STRUCT_DESC: 24-inch corrugated metal gravity drainage pipe through the levee, 18 feet below the crown. Corrugated metal cutoff wall around the pipe at the center of the levee. Flap gate and 6-foot by 6-foot splash apron on the waterside (WS) end. [Additional Reference(s): DWR Levee Log, 2005. USACE Sacramento O&M Manual 151, May 1953, (Station 339+55.10)]. FS Date: 4/29/2013

View of waterwar side--marker indicating crossing located on waterward shoulder.

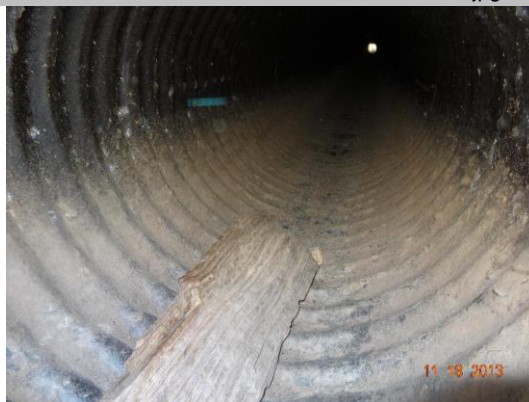
Photo 3 of 3 : UCIP_SP_2018_27747_51443.jpg

Internal view of pipe wall using camera with flash.

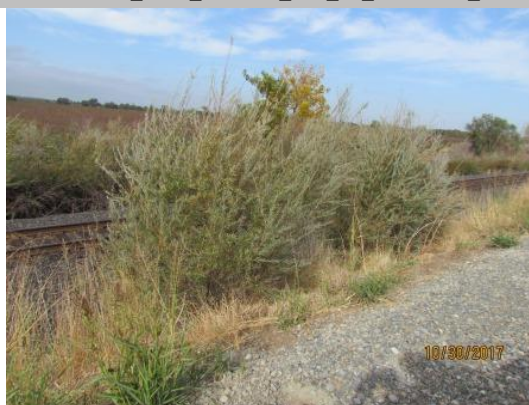
Photo 1 of 1 : SP_2018_RD0010_163_37_20180302_00012.jpg

LM Start	4.83	Rating **	M	Issue No.	37
LM End	4.83	Issue Type +	Ma	Location *	LS
Category	Earthen Levee			GPS Latitude/Longitude	
				Start	End
Item	Trim / Thin Trees			39.215597 °	39.215597 °
				-121.580046 °	-121.580046 °
DWR ID	DWR_RD0010_01_f_2017_37				
Comment Code					
T3 : Trim and thin trees to allow visibility of the ground and room to flood fight.					
Inspector Comment					
Small willow tree on landside slope should be removed. Fall 2017.

View of small willow trees on the landside slope looking upstream. Fall 2017.

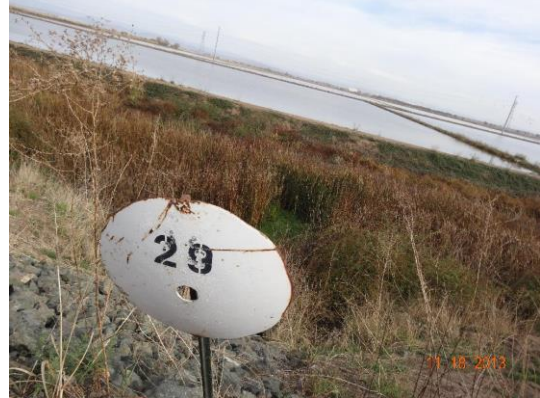
Photo 1 of 3 : UCIP_SP_2018_49988_44811.jpg

Comment Code						
Inspector Comment						
FS_ID:49988 DS_ID:21275 EP_NO: N/A Repair Type: Non-Urgent Crossing Status: Found UCIP Comments: 7/01/2016 WS slope appears to be stable; UCIP issue has been downgraded from Urgent to Non-Urgent due to what appears to be a stable slope--no other issues were observed during the site visit. The reason for the Non-Urgent classification is due to the limited documentation available to support extent of repair--need to obtain repair records to determine extent of repair and to determine if pipe was replaced through the levee. (DWR UCIP - omagana)4/29/2013 limited access; steep slopes, and dense vegetation; New riprap has been placed along pipe alignment need to contact owner to determine work authorization. Also need to find out if the design for riprap was due to slope failure at this location. This crossing is referenced in the USACE Periodic Inspection as item USACE_CESPK_HON1_2013_p_0246. (DWR UCIP - omagana) FIELD_STRUCT_DESC: 36-inch corrugated metal gravity drainage pipe through the levee, 20 feet below the crown. Two corrugated metal cutoff walls around the pipe on each shoulder. Flap gate on the waterside (WS) end. Concrete headwall on the WS toe. Grouted cobble headwall on the landside (LS) toe. Concrete saddle and apron on the WS. [Additional Reference(s): DWR Levee Log, 2005. USACE Sacramento O&M Manual 151, May 1953, (Station 381+76.24)]. FS Date: 7/1/2016

Marker for pipe crossing visible on WS shoulder.

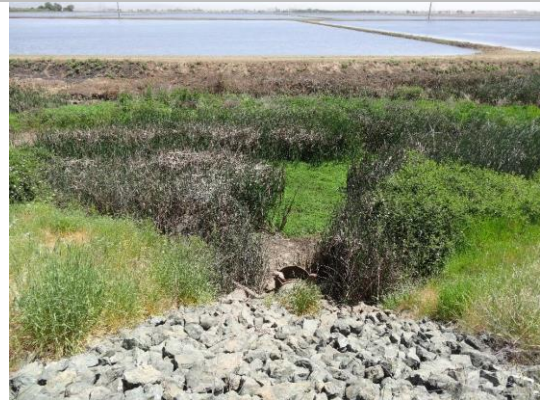
Photo 2 of 3 : UCIP_SP_2018_49988_44809.jpg

View of WS during April.

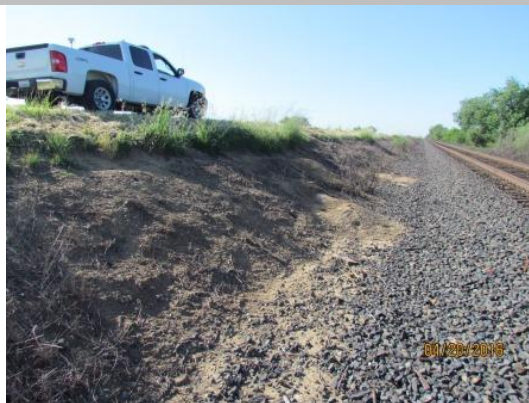
Photo 1 of 1 : SP_2018_RD0010_163_41_20180302_00014.jpg

LM Start	5.45	Rating **	M	Issue No.	41
LM End	5.45	Issue Type +	Ma	Location *	LS
Category	Earthen Levee			GPS Latitude/Longitude	
				Start	End
Item	Animal Control			39.224485 °	39.224485 °
				-121.578944 °	-121.578944 °
DWR ID	DWR_RD0010_01_s_2016_41				
Comment Code					
A3 : No rodents visible, but rodent burrows visible; need to backfill and compact or grout burrows.					
Inspector Comment					
Squirrel hole still are visible but no sign of activity, Fall 2017.

View of multiple active ground squirrel holes on landside slope looking downstream.

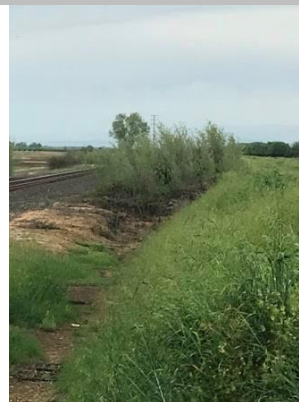
Photo 1 of 2 : SP_2018_RD0010_163_36_20180411_00102.jpg

LM Start	6.18	Rating **	M	Issue No.	36
LM End	6.34	Issue Type +	Ma	Location *	LS
Category	Earthen Levee			GPS Latitude/Longitude	
				Start	End
Item	Vegetation			39.235067 °	39.237286 °
				-121.577541 °	-121.577218 °
DWR ID	DWR_RD0010_01_s_2016_36				
Comment Code					
V2 : Remove the wild growth other than native grasses from the levee slopes.					
Inspector Comment					
Large cluster of willows and wild rosebushes on landside slope and toe. Spring 2018.

View looking upstream landside of willows and wild rosebushes that are blocking visibility on the slope, Spring 2018.

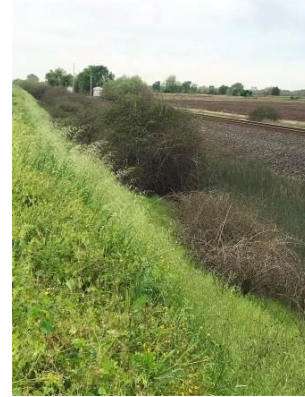
Photo 2 of 2 : SP_2018_RD0010_163_36_20180411_00103.jpg

LM Start	6.18	Rating **	M	Issue No.	36 (cont)	
LM End	6.34	Issue Type +	Ma	Location *	LS	
Category	Earthen Levee			GPS Latitude/Longitude		
				Start	End	
Item	Vegetation			39.235067 °	39.237286 °	
				-121.577541 °	-121.577218 °	
DWR ID	DWR_RD0010_01_s_2016_36					
Comment Code						
V2 : Remove the wild growth other than native grasses from the levee slopes.						
Inspector Comment						
Large cluster of willows and wild rosebushes on landside slope and toe. Spring 2018.

View looking downstream landside of willows and wild rosebushes that are blocking visibility on the slope, Spring 2018.

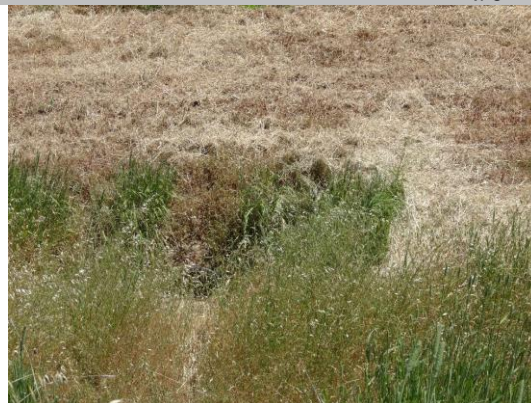
Photo 2 of 3 : UCIP_SP_2018_24438_43502.jpg

Comment Code						
Inspector Comment						
FS_ID:24438 DS_ID:21278 EP_NO: N/A Repair Type: Non-Urgent Crossing Status: Found UCIP Comments: Dense vegetation limits the inspector's visibility to identify signs of pipe failure (leaks) along the slope. Recommend removing vegetation along pipe alignment to conduct proper inspection of structure and appurtances. This crossing is referenced in the USACE Periodic Inspection as item USACE_CESPK_HON1_2013_p_0290. FIELD_STRUCT_DESC: 30-inch corrugated metal gravity drainage pipe through the levee, 12.5 feet below the crown. Corrugated metal cutoff wall around the pipe at each shoulder. Flap gate on the waterside (WS) end. Concrete headwall, saddle, and apron on the WS end. [Additional Reference(s): DWR Levee Log, 2005. USACE Sacramento O&M Manual 151, May 1953, (Station 455+00)]. FS Date: 4/29/2013

View of waterward toe where pipe daylights.

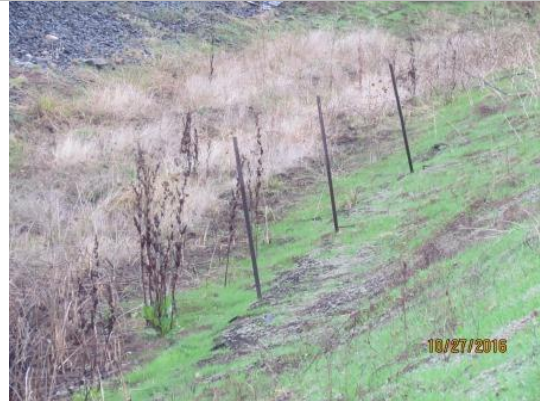
Photo 1 of 1 : SP_2018_RD0010_163_33_20180302_00007.jpg

LM Start	6.48	Rating **	M	Issue No.	33
LM End	7.13	Issue Type +	En	Location *	LS
Category	Earthen Levee			GPS Latitude/Longitude	
				Start	End
Item	Encroachments			39.239303 °	39.248725 °
				-121.576970 °	-121.575824 °
DWR ID	DWR_RD0010_01_s_2016_33				
Comment Code					
FE : Fence					
Inspector Comment					
Fence t-post at levee toe should be removed. Fall 2017.

View of fence post that run along the landside levee toe, looking upstream. Fall 2016.

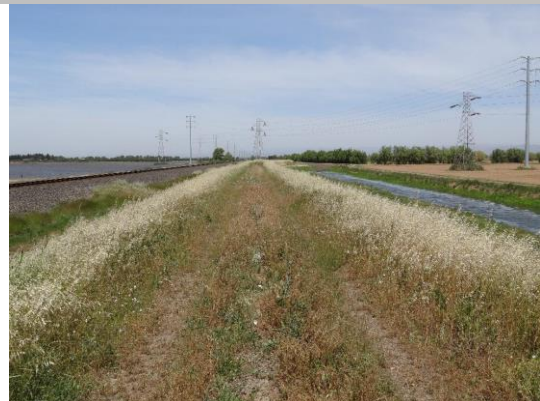
Photo 1 of 3 : UCIP_SP_2018_27532_51129.jpg

Comment Code						
Inspector Comment						
FS_ID:27532 DS_ID:21279 EP_NO: N/A Repair Type: Non-Urgent Crossing Status: Found UCIP Comments: Need to clear sediment near gate. Need to coordinate with owner to determine status of crossing. If crossing is no longer in use owner will need to contact the CVFPB to comply with Title 23. This crossing is referenced in the USACE Periodic Inspection as item USACE_CESPK_HON1_2013_p_0291-294. FIELD_STRUCT_DESC: 16-inch steel drainage pipe through the levee, 10.3 feet below the crown. Cutoff wall around the pipe at the center of the levee. Slide gate on the waterside (WS) end. Pipe exposed across irrigation canal on the landside (LS). [Additional Reference(s): DWR Levee Log, 2005. USACE Sacramento O&M Manual 151, May 1953, (Station 473+58)]. FS Date: 4/29/2013

View of levee looking upstream.

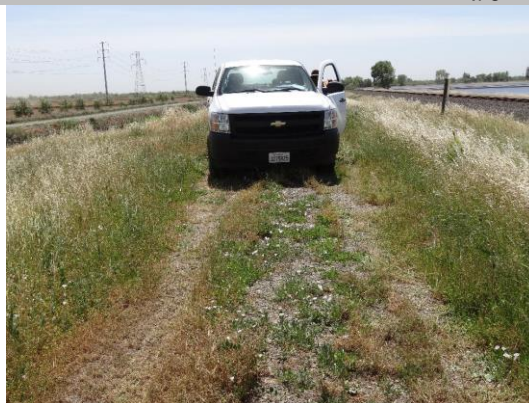
Photo 2 of 3 : UCIP_SP_2018_27532_51128.jpg

View of levee looking downstream.

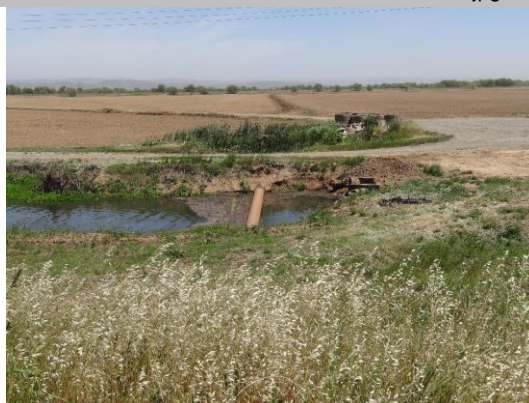
Photo 3 of 3 : UCIP_SP_2018_27532_51130.jpg

View of waterward side--pipe goes through Simmerly Slough.

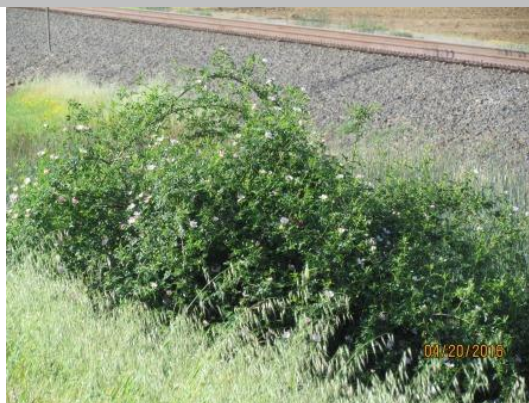
Photo 1 of 1 : SP_2018_RD0010_163_34_20180302_00008.jpg

LM Start	6.86	Rating **	M	Issue No.	34
LM End	6.86	Issue Type +	Ma	Location *	LS
Category	Earthen Levee			GPS Latitude/Longitude	
				Start	End
Item	Vegetation			39.244811 °	39.244811 °
				-121.576277 °	-121.576277 °
DWR ID	DWR_RD0010_01_s_2016_34				
Comment Code					
V2 : Remove the wild growth other than native grasses from the levee slopes.					
Inspector Comment					
Wild Rosebush on landside slope needs to be removed. Fall 2017.

View of thick wild rose bush that obstructs visibility of the landside slope and toe. Spring 2016.

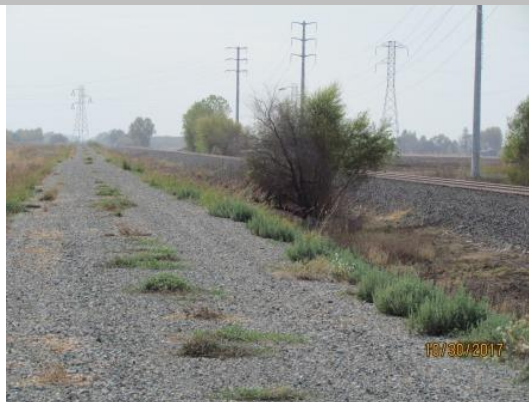
Photo 1 of 1 : SP_2018_RD0010_163_32_20180302_00006.jpg

LM Start	7.27	Rating **	M	Issue No.	32
LM End	7.27	Issue Type +	Ma	Location *	LS
Category	Earthen Levee			GPS Latitude/Longitude	
				Start	End
Item	Trim / Thin Trees			39.250651 °	39.250651 °
				-121.575579 °	-121.575579 °
DWR ID	DWR_RD0010_01_s_2016_32				
Comment Code					
T1 : Trim trees to at least five feet above ground level.					
Inspector Comment					
Small trees 4" in diameter at chest height should be removed before they get too big.

View of a tree that needs to be removed on the landside toe, looking downstream. Fall 2017.

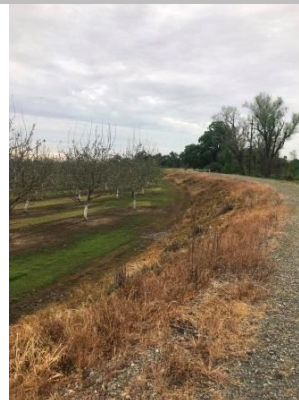
Photo 1 of 2 : SP_2018_RD0010_164_26_20180411_00101.jpg

LM Start	0.02	Rating **	A	Issue No.	26
LM End	11.32	Issue Type +	Ma	Location *	LS
Category	Earthen Levee			GPS Latitude/Longitude	
				Start	End
Item	Vegetation			39.163961 °	39.309530 °
				-121.610050 °	-121.616605 °
DWR ID	DWR_RD0010_02_s_2018_26				
Comment Code					
V1 : Control annual grass and weeds on the levee slopes and easements.					
Inspector Comment					
The annual vegetation is starting to get a little tall but is still maintained, Spring 2018.

View looking downstream landside of the well maintained annual vegetation, Spring 2018.

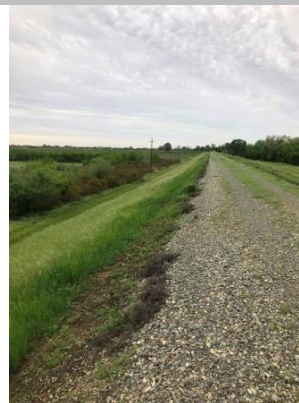
Photo 2 of 2 : SP_2018_RD0010_164_26_20180411_00103.jpg

LM Start	0.02	Rating **	A	Issue No.	26 (cont)	
LM End	11.32	Issue Type +	Ma	Location *	LS	
Category	Earthen Levee			GPS Latitude/Longitude		
				Start		End
Item	Vegetation			39.163961 °		39.309530 °
				-121.610050 °		-121.616605 °
DWR ID	DWR_RD0010_02_s_2018_26					
Comment Code						
V1 : Control annual grass and weeds on the levee slopes and easements.						
Inspector Comment						
The annual vegetation is starting to get a little tall but is still maintained, Spring 2018.

Second view looking downstream landside of the well maintained annual vegetation, Spring 2018.

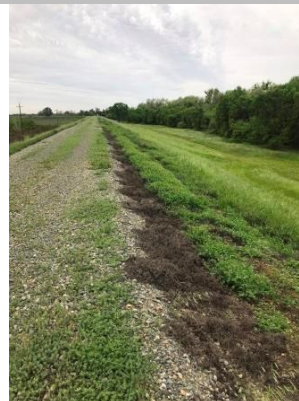
Photo 1 of 2 : SP_2018_RD0010_164_38_20180411_00106.jpg

LM Start	0.02	Rating **	A	Issue No.	38
LM End	11.32	Issue Type +	Ma	Location *	LS
Category	Earthen Levee			GPS Latitude/Longitude	
				Start	End
Item	Vegetation			39.163961 °	39.309530 °
				-121.610051 °	-121.616606 °
DWR ID	DWR_RD0010_02_s_2018_38				
Comment Code					
V1 : Control annual grass and weeds on the levee slopes and easements.					
Inspector Comment					
The annual vegetation is starting to get a little tall but is still maintained, Spring 2018.

Second view looking downstream waterside of the maintained annual vegetation, Spring 2018.

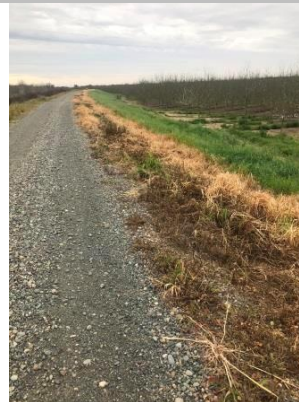
Photo 2 of 2 : SP_2018_RD0010_164_38_20180411_00105.jpg

View looking downstream waterside of the well maintained annual vegetation, Spring 2018.

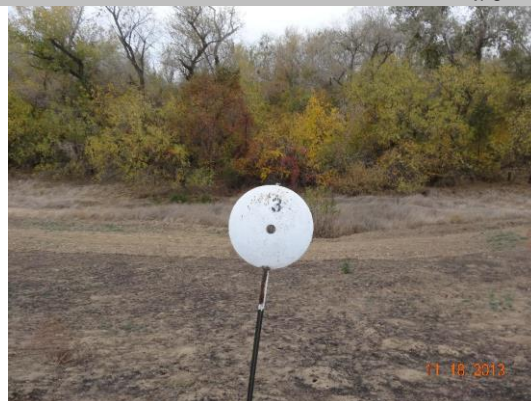
Photo 1 of 3 : UCIP_SP_2018_27533_51135.jpg

FS_ID:27533
DS_ID:21280
EP_NO: N/A
Repair Type: Non-Urgent
Crossing Status: Found
UCIP Comments: Recommend removing vegetation and debris along pipe alignment (debris blocking gate on waterward side and vegetation blocking access to screw gate on landward side). Need to coordinate with owner to determine status of crossing. If crossing is no longer in use owner will need to contact the CVFPB to comply with Title 23. This crossing is referenced in the USACE Periodic Inspection as item USACE_CESPK_HON2_2013_p_0027.
FIELD_STRUCT_DESC: 24-inch corrugated metal gravity drainage pipe through the levee, 25.6 feet below the crown. Corrugated metal cutoff wall around the pipe at each shoulder. Flap gate on the waterside (WS) end. Concrete headwall, saddle, and apron on the WS end. [Additional Reference(s): DWR Levee Log, 2005. USACE Sacramento O&M Manual 151, May 1953, (Station 106+00)].
FS Date: 4/30/2013

View of waterward side.

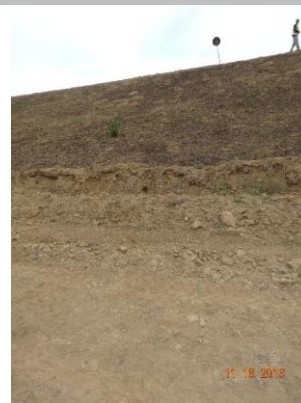
Photo 2 of 3 : UCIP_SP_2018_27533_51137.jpg

View of waterward slope.

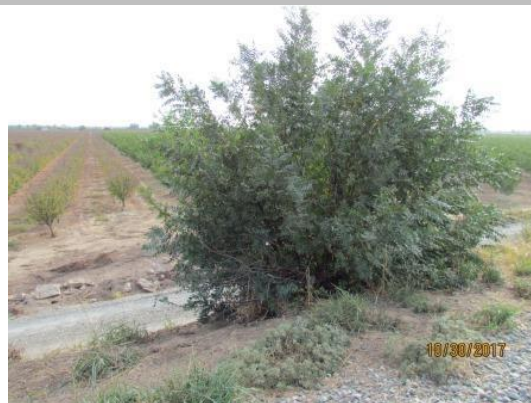
Photo 1 of 1 : SP_2018_RD0010_164_56_20180302_00028.jpg

LM Start	1.16	Rating **	M	Issue No.	56
LM End	1.16	Issue Type +	Ma	Location *	LS
Category	Earthen Levee			GPS Latitude/Longitude	
				Start	End
Item	Trim / Thin Trees			39.180447 °	39.180447 °
				-121.610036 °	-121.610036 °
DWR ID	DWR_RD0010_02_f_2017_56				
Comment Code					
T2 : Thin trees to allow visibility of the ground and room to flood fight.					
Inspector Comment					
Tree less than 4" in diameter needs to be removed, Fall 2017.

View looking downstream landside of a tree less than 4" in diameter that needs to be removed, Fall 2017.

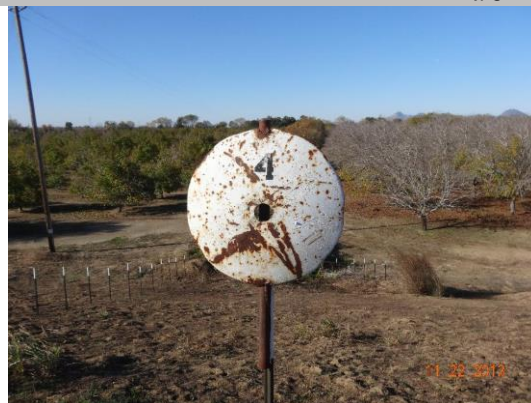
Photo 1 of 3 : UCIP_SP_2018_24821_44640.jpg

Comment Code						
Inspector Comment						
FS_ID:24821						
DS_ID:21281						
EP_NO: N/A						
Repair Type: Non-Urgent						
Crossing Status: Found						
UCIP Comments: Screw gate on landward side is blocked by sediment.						
Recommend removing sediment in front of gate. This crossing is						
referenced in the USACE Periodic Inspection as item						
USACE_CESPK_HON2_2013_p_0082.						
FIELD_STRUCT_DESC: 24-inch corrugated metal gravity drainage pipe						
through the levee, 26 feet below the crown. Corrugated metal cutoff wall						
around the pipe at each shoulder. Flap gate on the waterside (WS) end.						
Slide gate on the landside (LS) end. Concrete headwall, saddle, and						
apron on the WS end. [Additional Reference(s): DWR Levee Log, 2005.						
USACE Sacramento O&M Manual 151, May 1953, (Station 149+88)].						
FS Date: 4/30/2013

Marker visible on waterward side--No. 4.

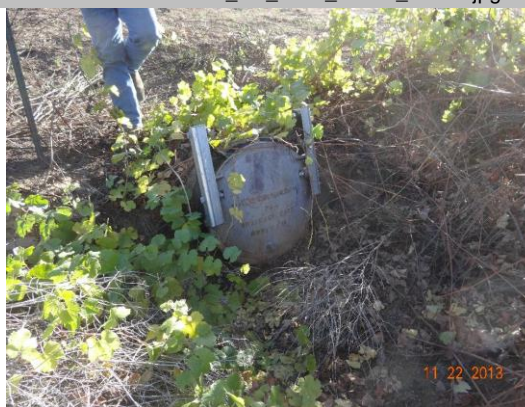
Photo 3 of 3 : UCIP_SP_2018_24821_44638.jpg

View of flap gate located on waterward side.

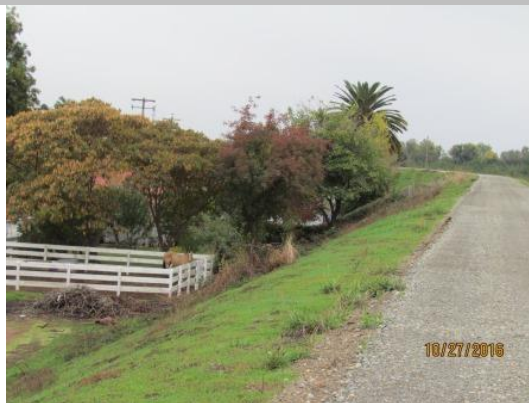
Photo 1 of 1 : SP_2018_RD0010_164_9_20180302_00002.jpg

LM Start	1.34	Rating **	M	Issue No.	9
LM End	1.34	Issue Type +	En	Location *	LS
Category	Earthen Levee			GPS Latitude/Longitude	
				Start	End
Item	Vegetation			39.182957 °	39.182957 °
				-121.609800 °	-121.609800 °
DWR ID	DWR_RD0010_02_s_2012_9				
Comment Code					
V6 : Landscaping					
Inspector Comment					
Landscaping and fence should be removed from levee toe and slope.

View of homeowners landscaping and fence that encroaches on the landside levee slope, looking downstream.

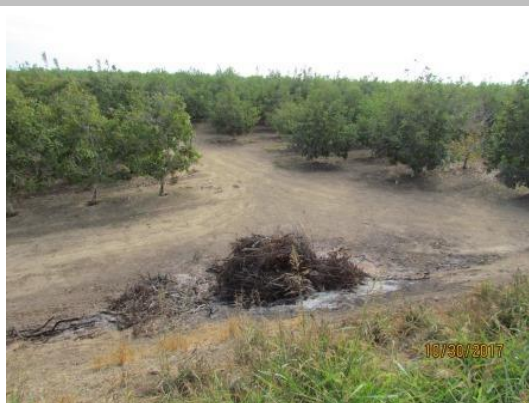
Photo 1 of 1 : SP_2018_RD0010_164_39_20180302_00014.jpg

LM Start	1.80	Rating **	M	Issue No.	39
LM End	1.80	Issue Type +	En	Location *	LS
Category	Earthen Levee			GPS Latitude/Longitude	
				Start	End
Item	Encroachments			39.189467 °	39.189467 °
				-121.607991 °	-121.607991 °
DWR ID	DWR_RD0010_02_s_2016_39				
Comment Code					
PR : Prunings					
Inspector Comment					
Remove pruning's from toe of slope.

View of pruning's at landside levee toe, Fall 2017.

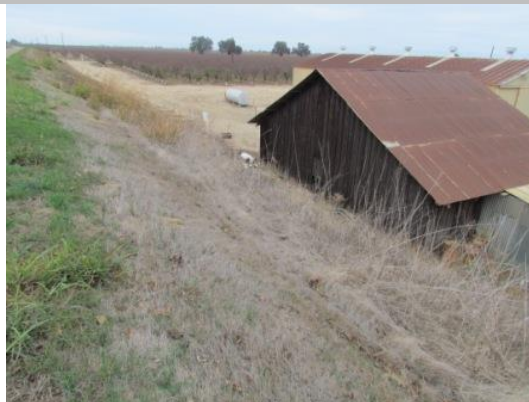
Photo 1 of 1 : SP_2018_RD0010_164_65_20180302_00031.jpg

LM Start	2.12	Rating **	M	Issue No.	65
LM End	2.12	Issue Type +	En	Location *	LS
Category	Earthen Levee			GPS Latitude/Longitude	
				Start	End
Item	Encroachments			39.194178 °	39.194178 °
				-121.607880 °	-121.607880 °
DWR ID	DWR_RD0010_02_f_2013_65				
Comment Code					
BU : Building					
Inspector Comment					
Unpermitted building at landside levee toe.

This photo was taken from the crown facing north looking down the landward levee slope at an outbuilding near the levee toe.

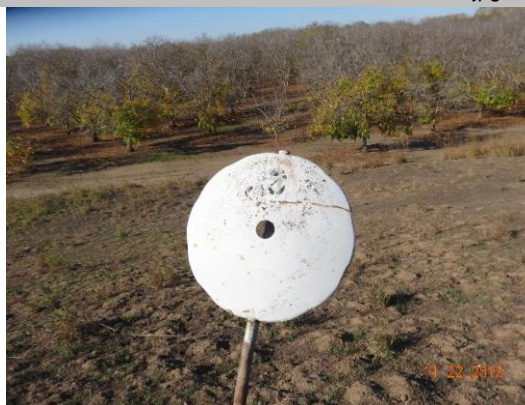
Photo 1 of 3 : UCIP_SP_2018_27773_51461.jpg

LM Start	3.10	Rating **	M	Issue No.	82	
LM End	3.10	Issue Type +	En	Location *		
Category	Supplemental			GPS Latitude/Longitude		
				Start		End
Item	DWR UCIP Field Study			39.208193 °		39.208193 °
				-121.609909 °		-121.609909 °
DWR ID						
Comment Code						
Inspector Comment						
FS_ID:27773						
DS_ID:21283						
EP_NO: N/A						
Repair Type: Non-Urgent						
Crossing Status: Found						
UCIP Comments: High rodent activity along pipe alignment--animal control would be beneficial. This crossing is referenced in the USACE Periodic Inspection as item USACE_CESPK_HON2_2013_p_0150.						
FIELD_STRUCT_DESC: 30-inch corrugated metal gravity drainage pipe through the levee, 22.5 feet below the crown. Flap gate on the waterside (WS) end. Metal marker on the WS shoulder. [Additional Reference(s): DWR Levee Log, 2005].						
FS Date: 4/30/2013

Marker visible on waterward side.

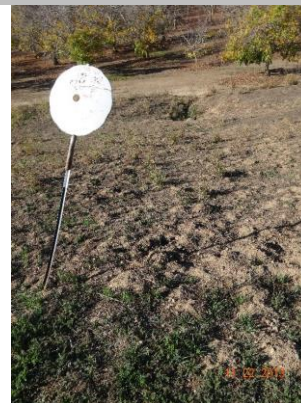
Photo 2 of 3 : UCIP_SP_2018_27773_51460.jpg

LM Start	3.10	Rating **	M	Issue No.	82 (cont)	
LM End	3.10	Issue Type +	En	Location *		
Category	Supplemental			GPS Latitude/Longitude		
				Start	End	
Item	DWR UCIP Field Study			39.208193 °	39.208193 °	
				-121.609909 °	-121.609909 °	
DWR ID						
Comment Code						
Inspector Comment						
FS_ID:27773 DS_ID:21283 EP_NO: N/A Repair Type: Non-Urgent Crossing Status: Found UCIP Comments: High rodent activity along pipe alignment--animal control would be beneficial. This crossing is referenced in the USACE Periodic Inspection as item USACE_CESPK_HON2_2013_p_0150. FIELD_STRUCT_DESC: 30-inch corrugated metal gravity drainage pipe through the levee, 22.5 feet below the crown. Flap gate on the waterside (WS) end. Metal marker on the WS shoulder. [Additional Reference(s): DWR Levee Log, 2005]. FS Date: 4/30/2013

View of waterward side--burrow activity present on slope.

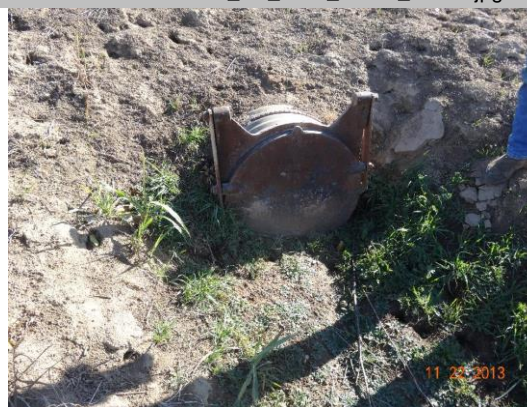
Photo 3 of 3 : UCIP_SP_2018_27773_51464.jpg

View of gate on waterward side.

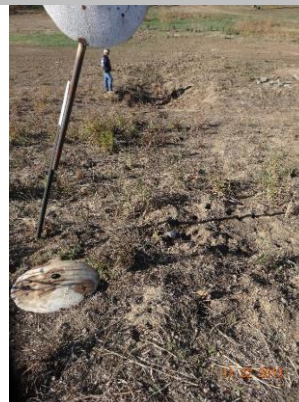
Photo 1 of 1 : SP_2018_RD0010_164_7_20180302_00001.jpg

LM Start	3.60	Rating **	M	Issue No.	7
LM End	3.60	Issue Type +	Ma	Location *	LS
Category	Earthen Levee			GPS Latitude/Longitude	
				Start	End
Item	Animal Control			39.215338 °	39.215338 °
				-121.610751 °	-121.610751 °
DWR ID	DWR_RD0010_02_s_2016_7				
Comment Code					
A3 : No rodents visible, but rodent burrows visible; need to backfill and compact or grout burrows.					
Inspector Comment					
There is no rodent activity, but the holes needs to be properly backfilled. Fall 2017.

View of waterward slope--burrow activity present.

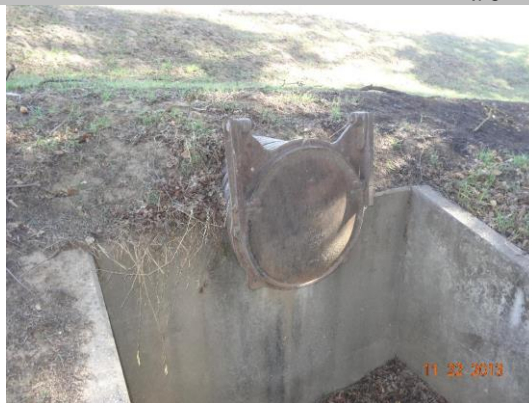
Photo 3 of 3 : UCIP_SP_2018_24826_44673.jpg

Comment Code						
Inspector Comment						
FS_ID:24826						
DS_ID:21286						
EP_NO: N/A						
Repair Type: Non-Urgent						
Crossing Status: Found						
UCIP Comments: Deformation observed on the top wall of pipe at the entrance of landward side--need to contact owner to address issue. This crossing is referenced in the USACE Periodic Inspection as item USACE_CESPK_HON2_2013_p_0180.						
FIELD_STRUCT_DESC: 30-inch corrugated metal gravity drainage pipe through the levee, 21.5 feet below the crown. Corrugated metal cutoff walls around the pipe at each shoulder. Flap gate on the waterside (WS) end. Slide gate on the landside (LS) end. Concrete headwall at each end. [Additional Reference(s): DWR Levee Log, 2005. USACE Sacramento O&M Manual 151, May 1953, (Station 294+84)].						
FS Date: 4/30/2013

View of flapgate on concrete head wall on waterward side.

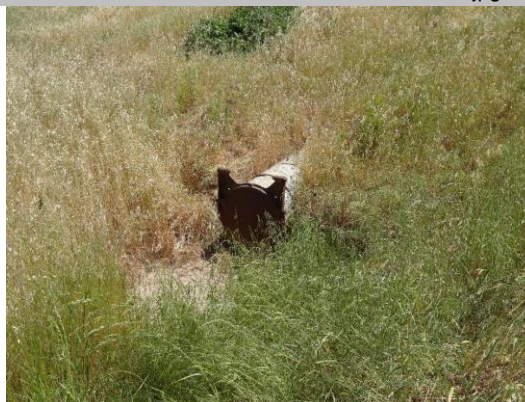
Photo 2 of 3 : UCIP_SP_2018_24751_44376.jpg

View of flap gate on waterward side.

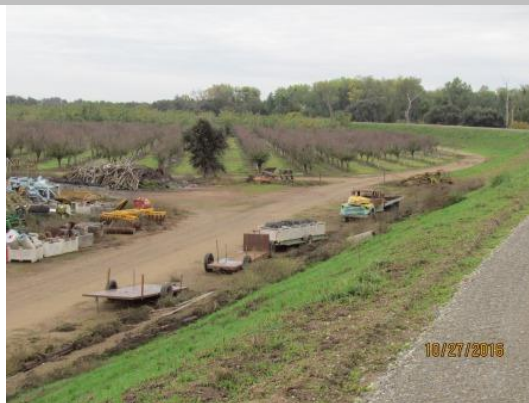
Photo 2 of 2 : SP_2018_RD0010_164_31_20180302_00007.jpg

LM Start	4.44	Rating **	M	Issue No.	31 (cont)	
LM End	4.48	Issue Type +	En	Location *	LS	
Category	Earthen Levee			GPS Latitude/Longitude		
				Start		End
Item	Encroachments			39.226946 °	39.227445 °	
				-121.613048 °	-121.612718 °	
DWR ID	DWR_RD0010_02_f_2015_31					
Comment Code						
EQ : Equipment						
Inspector Comment						
Remove equipment from levee toe. Fall 2017.

View of the equipment at the toe of the levee on the landward side of the levee looking downstream.

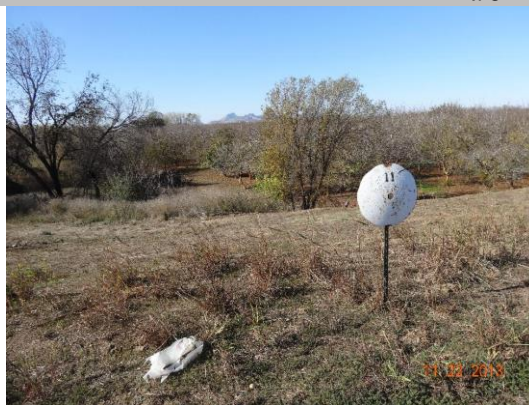
Photo 2 of 3 : UCIP_SP_2018_27774_51470.jpg

View of waterward side.

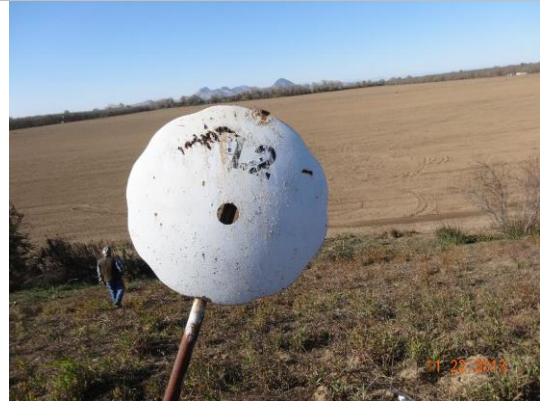
Photo 1 of 3 : UCIP_SP_2018_24828_44680.jpg

View of marker located on waterward shoulder--crossing referenced as No. 12.

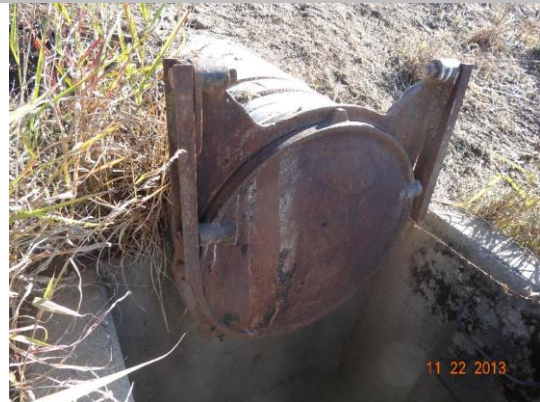
Photo 2 of 3 : UCIP_SP_2018_24828_44684.jpg

View of flap gate located on waterward side.

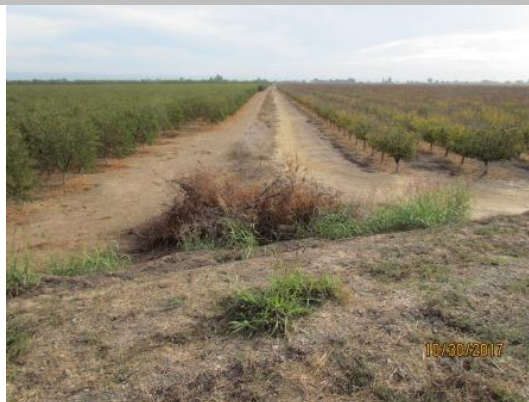
Photo 1 of 1 : SP_2018_RD0010_164_49_20180302_00022.jpg

LM Start	6.36	Rating **	M	Issue No.	49
LM End	6.36	Issue Type +	En	Location *	LS
Category	Earthen Levee			GPS Latitude/Longitude	
				Start	End
Item	Encroachments			39.253524 °	39.253524 °
				-121.619448 °	-121.619448 °
DWR ID	DWR_RD0010_02_s_2016_49				
Comment Code					
PR : Prunings					
Inspector Comment					
Remove pruning's, Fall 2017.

View of pruning's at landside levee toe, Fall 2017.

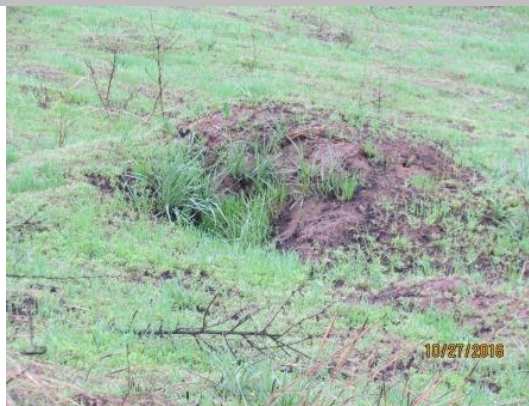
Photo 1 of 1 : SP_2018_RD0010_164_33_20180302_00009.jpg

LM Start	6.88	Rating **	U	Issue No.	33
LM End	6.88	Issue Type +	Ma	Location *	WS
Category	Earthen Levee			GPS Latitude/Longitude	
				Start	End
Item	Animal Control			39.259843 °	39.259843 °
				-121.616013 °	-121.616013 °
DWR ID	DWR_RD0010_02_f_2015_33				
Comment Code					
A3 : No rodents visible, but rodent burrows visible; need to backfill and compact or grout burrows.					
Inspector Comment					
Rodent hole that has more than 2 cubic feet of material, this hole is not active but needs to be backfilled properly.

View of rodent hole that has more than 2 cubic feet of material, this hole is not active but needs to be backfilled properly.

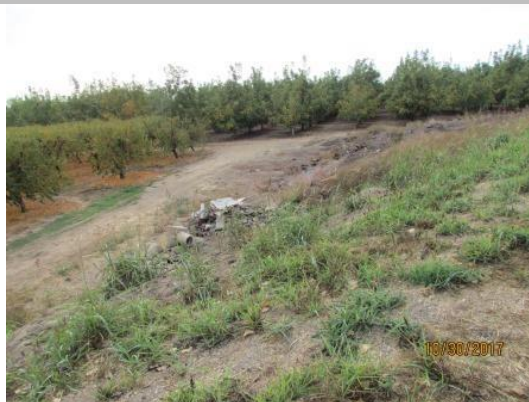
Photo 1 of 1 : SP_2018_RD0010_164_53_20180302_00025.jpg

LM Start	7.07	Rating **	M	Issue No.	53
LM End	7.07	Issue Type +	En	Location *	LS
Category	Earthen Levee			GPS Latitude/Longitude	
				Start	End
Item	Encroachments			39.262290 °	39.262290 °
				-121.614390 °	-121.614390 °
DWR ID	DWR_RD0010_02_s_2016_53				
Comment Code					
DE : Debris					
Inspector Comment					
Remove debris from levee toe. Fall 2017.

View looking downstream of debris at landside levee toe, Fall 2017.

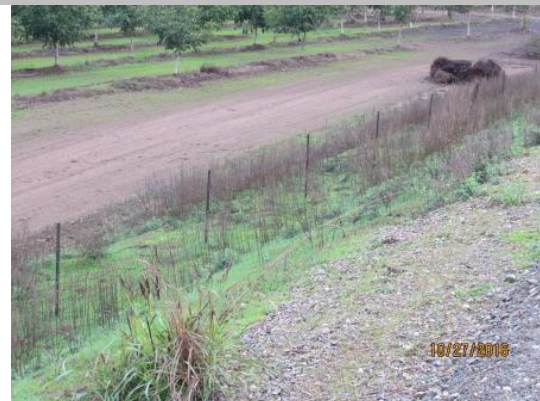
Photo 1 of 1 : SP_2018_RD0010_164_55_20180302_00027.jpg

LM Start	7.31	Rating **	M	Issue No.	55
LM End	11.34	Issue Type +	En	Location *	LS
Category	Earthen Levee			GPS Latitude/Longitude	
				Start	End
Item	Encroachments			39.265726 °	39.309707 °
				-121.613676 °	-121.616552 °
DWR ID	DWR_RD0010_02_s_2016_55				
Comment Code					
FE : Fence					
Inspector Comment					
Fence runs along landside levee toe.

View of fence at landside levee toe looking downstream.

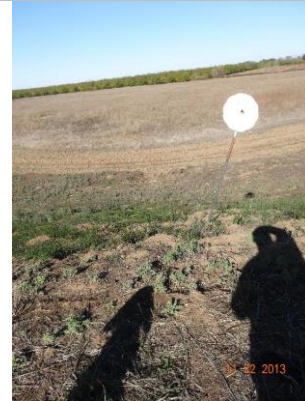
Photo 1 of 3 : UCIP_SP_2018_27775_51473.jpg

Comment Code					
Inspector Comment					
FS_ID:27775 DS_ID:21296 EP_NO: N/A Repair Type: Non-Urgent Crossing Status: Found UCIP Comments: Sediment build-up at the inlet--recommend clearing sediment. This crossing is referenced in the USACE Periodic Inspection as item USACE_CESPK_HON2_2013_p_0348. FIELD_STRUCT_DESC: 30-inch corrugated metal gravity drainage pipe through the levee, 23 feet below the crown. Corrugated metal cutoff wall around the pipe at each shoulder. Flap gate on the waterside (WS) end. Slide gate on the landside (LS) end. Concrete headwall at each end. Metal marker on the WS shoulder. [Additional Reference(s): DWR Levee Log, 2005. USACE Sacramento O&M Manual 151, May 1953, (Station 551+96)]. FS Date: 4/30/2013

View of waterward side.

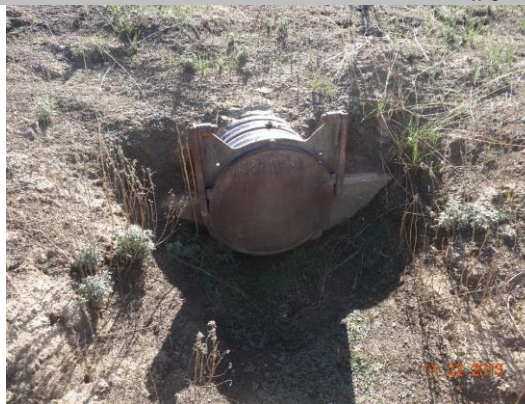
Photo 3 of 3 : UCIP_SP_2018_27775_51477.jpg

View of flap gate visible on waterward side.

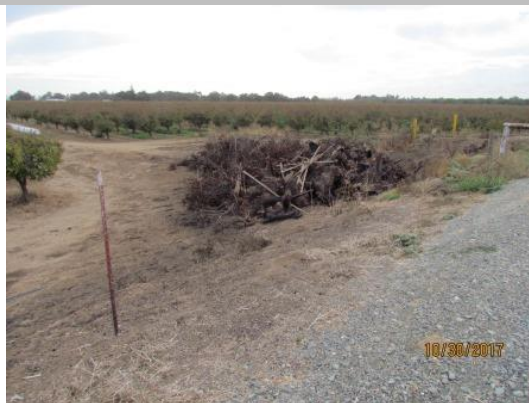
Photo 1 of 1 : SP_2018_RD0010_164_48_20180302_00021.jpg

LM Start	8.93	Rating **	M	Issue No.	48
LM End	8.93	Issue Type +	En	Location *	LS
Category	Earthen Levee			GPS Latitude/Longitude	
				Start	End
Item	Encroachments			39.281033 °	39.281033 °
				-121.600088 °	-121.600088 °
DWR ID	DWR_RD0010_02_f_2017_48				
Comment Code					
PR : Prunings					
Inspector Comment					
Remove pruning's from levee toe, Fall 2017.

View looking downstream landside of pruning's on levee toe, Fall 2017.

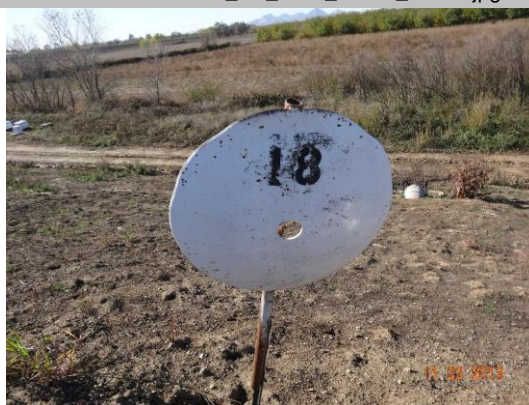
Photo 1 of 3 : UCIP_SP_2018_24834_44715.jpg

Comment Code						
Inspector Comment						
FS_ID:24834 DS_ID:21297 EP_NO: N/A Repair Type: Non-Urgent Crossing Status: Found UCIP Comments: Slide gate missing on landward side. Need to contact owner to determine status of crossing. This crossing is referenced in the USACE Periodic Inspection as item USACE_CESPK_HON2_2013_p_0367. FIELD_STRUCT_DESC: 24-inch corrugated metal gravity drainage pipe through the levee, 14 feet below the crown. Corrugated metal cutoff wall around the pipe at each shoulder. Flap gate on the waterside (WS) end. Slide gate on the landside (LS), slide gate missing. Concrete headwall, saddle, and apron on the WS end. 6-foot by 6-foot concrete splash apron at the WS toe. [Additional Reference(s): DWR Levee Log, 2005. USACE Sacramento O&M Manual 151, May 1953, (Station 565+74)]. FS Date: 4/30/2013

Marker visible on waterward shoulder, crossing is referenced as No. 18.

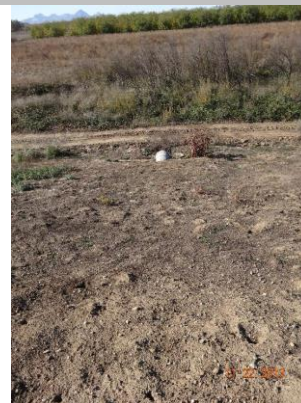
Photo 2 of 3 : UCIP_SP_2018_24834_44714.jpg

View of waterward side.

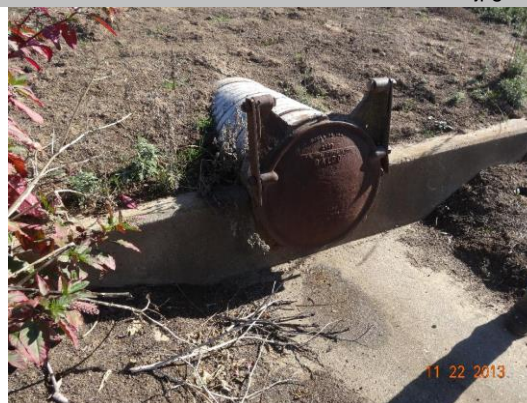
Photo 3 of 3 : UCIP_SP_2018_24834_44716.jpg

View of flap gate visible on waterward side.

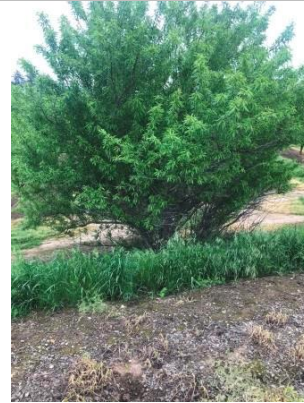
Photo 1 of 1 : SP_2018_RD0010_164_66_20180411_00108.jpg

LM Start	9.02	Rating **	M	Issue No.	66
LM End	9.02	Issue Type +	Ma	Location *	LS
Category	Earthen Levee			GPS Latitude/Longitude	
				Start	End
Item	Trim / Thin Trees			39.282329 °	39.282329 °
				-121.600161 °	-121.600161 °
DWR ID	DWR_RD0010_02_s_2016_66				
Comment Code					
T2 : Thin trees to allow visibility of the ground and room to flood fight.					
Inspector Comment					
Peach tree at toe should be removed, Spring 2018.

View of small peach tree on the landside toe looking downstream that should be removed, Spring 2018.
